# Manhole Inspection Summary

Manhole # S15EE1024MH

Insp Date: **3/5/07 10:02 AM**

**Location** Address: **2501 SHIRLEY AVE**

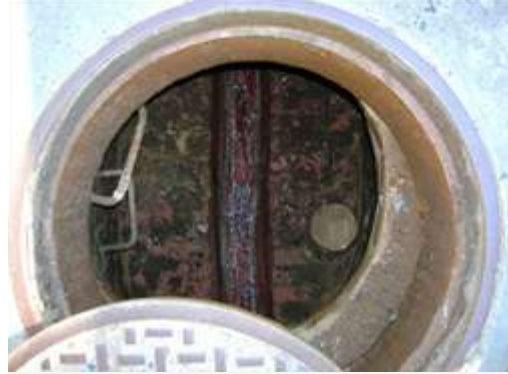
Top View

Evidence of surcharge - Bench debris.

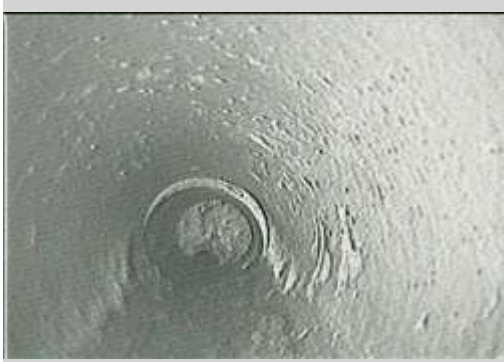
Inside the I6

Heavy root intrusion.

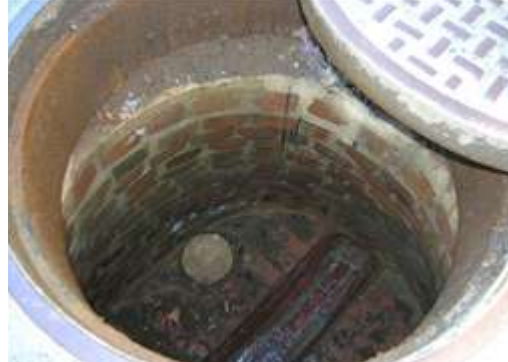
Defect

Frame leaks. Frame offset. Adjustment and Barrel infiltration.

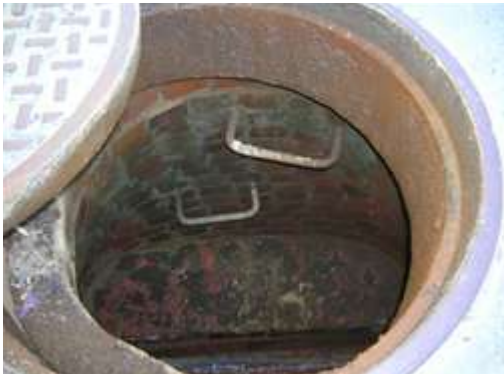
Defect

Frame leaks. Frame offset. Adjustment and Corbel infiltration - other side.

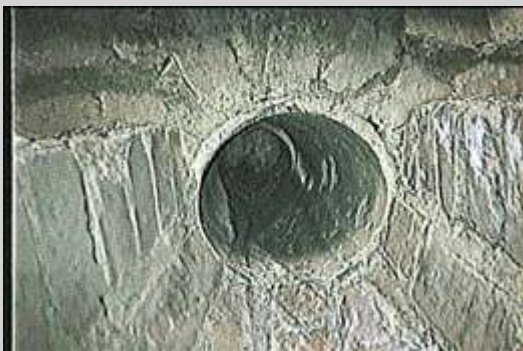
### 8 in. Circular Gravity Sewer Pipe In @ 6 O'Clock

Barrel deterioration and infiltration. Channel deterioration.

Infiltration: **Evidence** Pipe Seal Cond: **Cracked**
